Improving Highway Safety: Deception Pass Log Rail

January 2005

Crash test

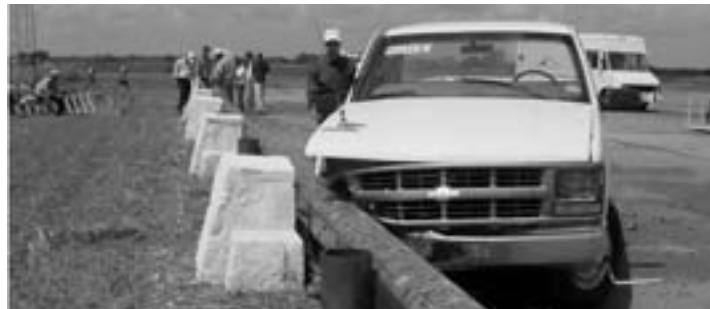
The new barrier design was successfully crash tested in accordance with the NCHRP Report 350 (1) requirements for Test Level 2.

Test Agency Texas Transportation Institute
Test 1 400561-2
Date 06/14/2004

Type Guardrail
Name Deception Pass State Park Log Rail

Installation Length (ft) 126.0 (38.4 m)
Material or Key Elements Steel-Backed Log Rail

Supported by Stone Bollards and Steel Pipe Posts

Speed (mph) 44.7 (71.9 km/h)
Angle (deg) 25.0

Impact Velocity (ft/s)
Longitudinal 23.0 (7.0 m/s)
Lateral 16.7 (5.1 m/s)
THIV (km/h) 29.7
Ridedown Accelerations (g's)
Longitudinal -4.2
Lateral -3.9
PHD (g's) 7.1
ASI 1.09

VDS 01RF2
CDC 01RFEW2
Maximum Exterior
Vehicle Crush 23.6 (inches)
..... (600 mm)

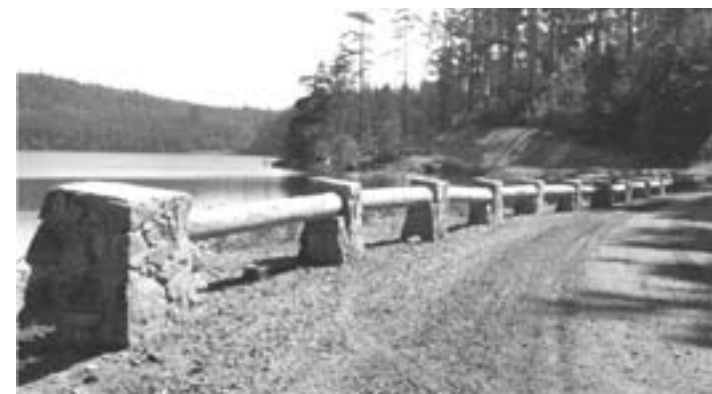
Original CCC log rail.

The portion of SR 20 within the park was constructed by the Civilian Conservation Corps (CCC) in the mid 1930's. As part of this work, the CCC constructed a stone masonry bollard and log rail system to delineate the edge of the road and prevent early model vehicles from leaving the roadway. Due to their age, quality of workmanship, and importance to the surroundings, the bridges and log rails are eligible for the National Register of Historic Places.

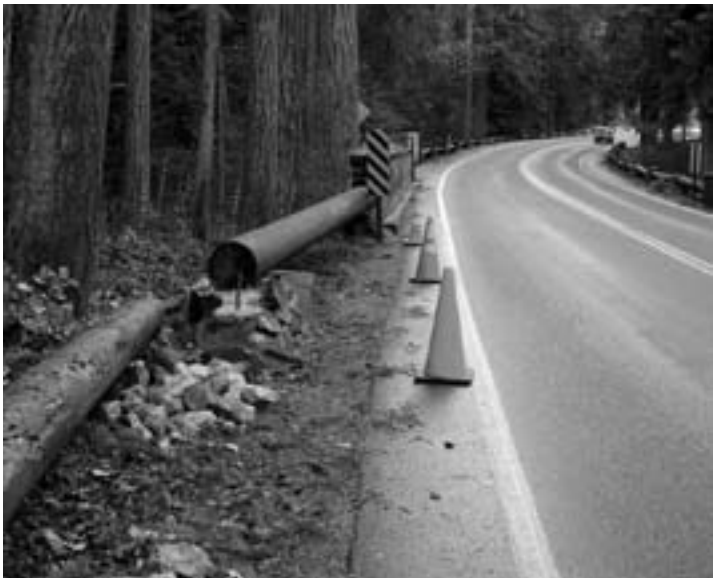
CCC rail after an impact.

In addition to the increased number of injury accidents, the repair of the CCC rail is very difficult. In many cases, the rock bollards have been destroyed.

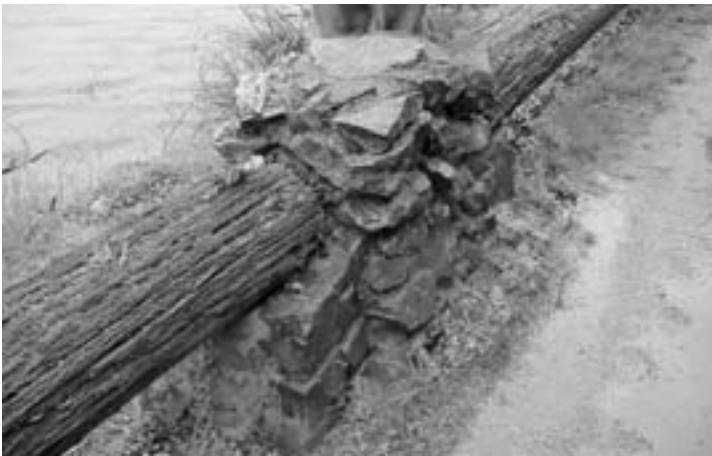
The Texas Transportation Institute (TTI) designed a barrier that incorporated 6 of the 10 character defining features.

This barrier design was accepted by the stakeholders for the WSPRC and the State Historic Preservation Office
